## THE QUEEN'S GUARD ROOM

### A LARGE-SCALE HERITAGE RESTORATION UNDERTAKEN BETWEEN 2015 AND 2018

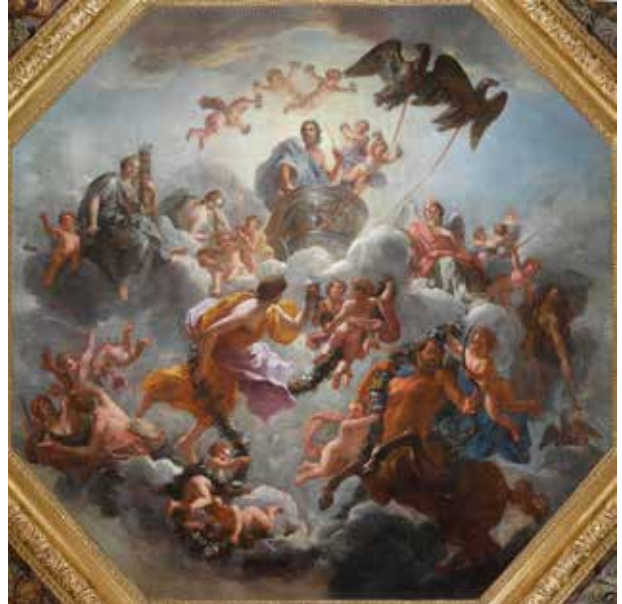
Central ceiling décor in the Queen's Guard Room, post-restoration  
© RMN-Grand Palais (Palace of Versailles) / Franck Raux

The gilded stucco decorations on the ceiling (borders and cornicing) were completely restored, the royal cyphers and emblems, which were re-established after the Revolution at the request of Louis XVIII, were preserved in situ – at the frieze level of the cornicing – and now stand out in gold on a pale grey background, whereas, originally, the whole cornice was gilded. Particular care and attention were also devoted to the room's extremely high-quality works in gilded lead (overdoor trophies, large hanging garlands, etc.). The old gilding was consolidated, while the mismatched bronzing and gilding were removed and remedied.

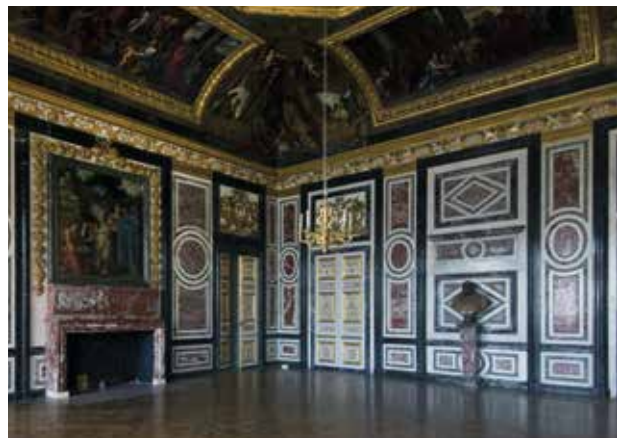
The Queen's Guard Room, post-restoration  
© Palace of Versailles, Didier Saulnier

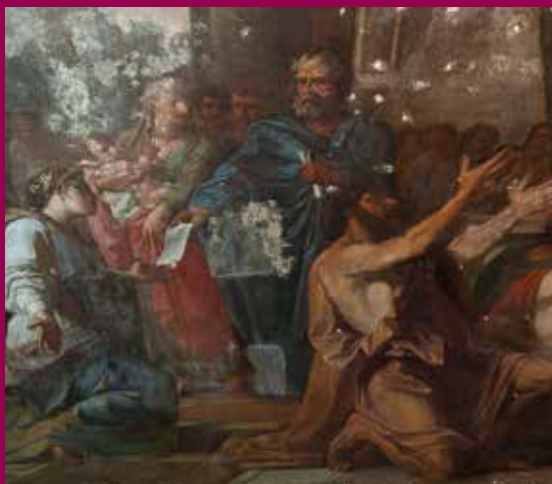
At the start of the essential restoration work, the state of conservation of the ceiling was concerning and chaotic. The canvases were warped and full of blisters, wrinkles, cracks, dents and flaking, while the plaster in the spandrels had cracks. Heavy repainting, wear and tear, myriad small cracks and oxidised varnishes disturbed the overall impression. The central, most damaged part was 80% repainted; whole sections of the composition, such as the faces, were completely redone and the flattened parts underwent successive treatments.

Detail from the ceiling in the Queen's Guard room, before and after restoration  
© Palace of Versailles, Christian Milet

The cleaning process revealed more gaps and wear. A thin layer of covering liquid – yellow/orange in colour – was applied to the surface, which concealed much of the repaint embedded in the varnish layers. All of this substantially altered the colour palette of the work, even to the point of changing the original scheme. This work restored the brightness of the colours and really brought out the parts that were entirely produced by the hand of Noël Coypel.

The rehabilitation of the pictorial layer emphasised the remaining elements of the original canvases and made the composition as a whole more harmonious. The conservators' aim was to preserve a certain level of wear while, at the same time, recreating the missing contours so as to prevent the blurred areas from spoiling the spirit of the painting.

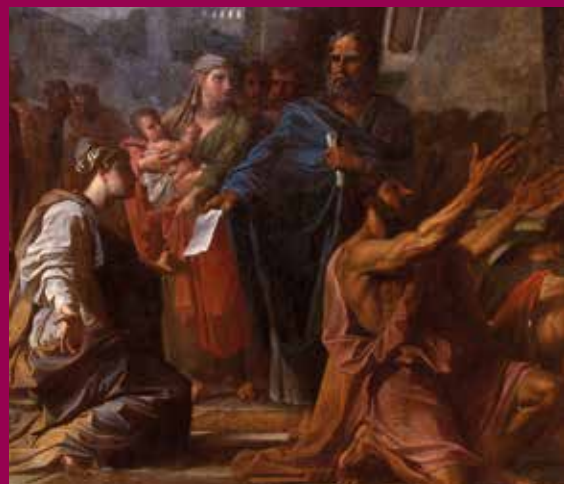
Incidentally, the two Noël Coypel paintings on the walls did not require any essential restoration, but they were, nevertheless, thoroughly cleaned and some distracting repaints were treated. As for the two canvas supports, some tensioning issues were dealt with.

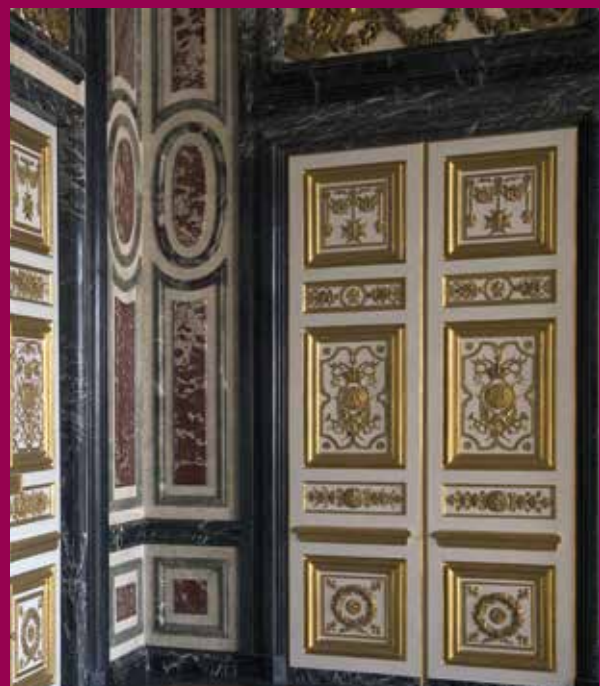
View of the polychrome marble décor and sculpted doors  
© Palace of Versailles, Didier Saulnier

The restoration conducted from 2015 to 2019 focused on the room's architectural décor as a whole. The marble panels were in a bad way – dull, dirty, full of cracks and gaps – so they were dusted and cleaned. The joints were cleaned out and the gaps filled in.

A considerable amount of work had to be done on the doors, which had been severely damaged through use. Their sculpted and gilded décor, fortified in 1814 with carton-pierre in the upper and lower sections, was cleaned and filled in, as there were several gaps. The gilding and painted pale-grey backgrounds were also redone; owing to their fragility, they will be protected under glass, like other decorative elements in the State Apartment. Finally, in line with the 1814 reference condition, the windows were repainted in yellow ochre rather than gilded.
